EROSION LOSSES

from a 3-day

CALIFORNIA STORM

UNITED STATES DEPARTMENT OF AGRICULTURE
SOIL CONSERVATION SERVICE

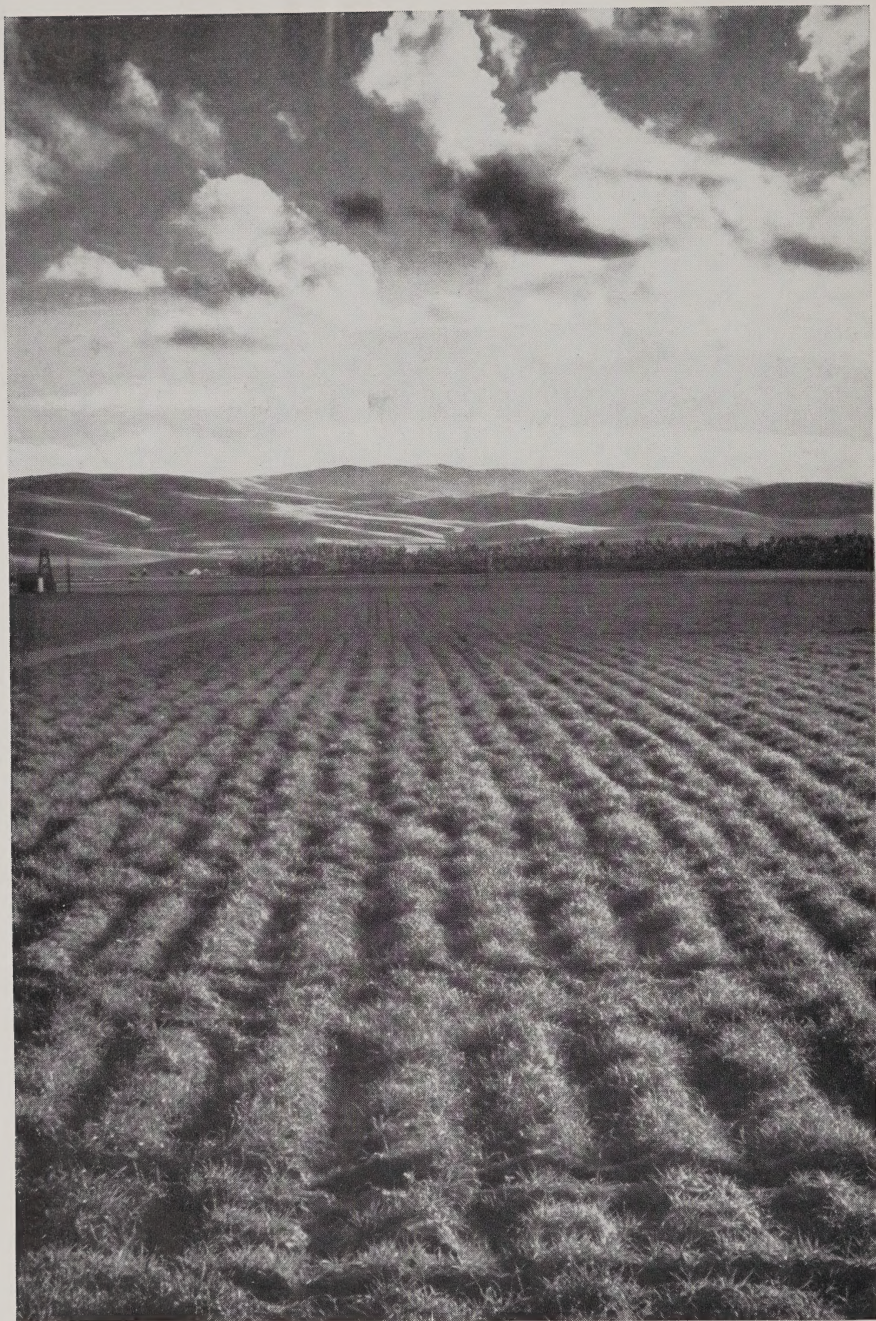
This field held the water from an 8-inch rain.

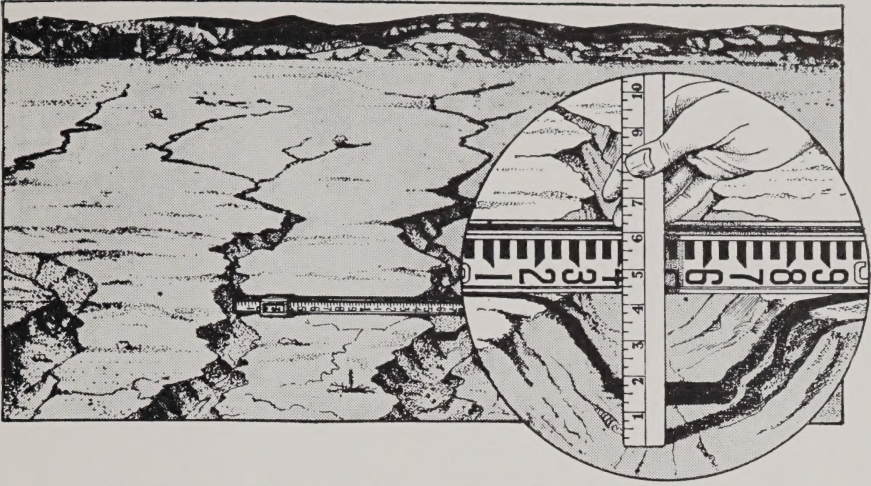
This diagram shows how measurements of soil loss were made.

The soil losses in the five demonstration areas were determined by sampling. A number of representative cross sections were selected in each field. The loss of soil was determined by placing a straight-edge on the ground level and measuring the eroded profile, as shown in the first illustration on the opposite page. The average soil loss was computed for each sample, and the average of all samples from a field was taken to be the average loss of that field.

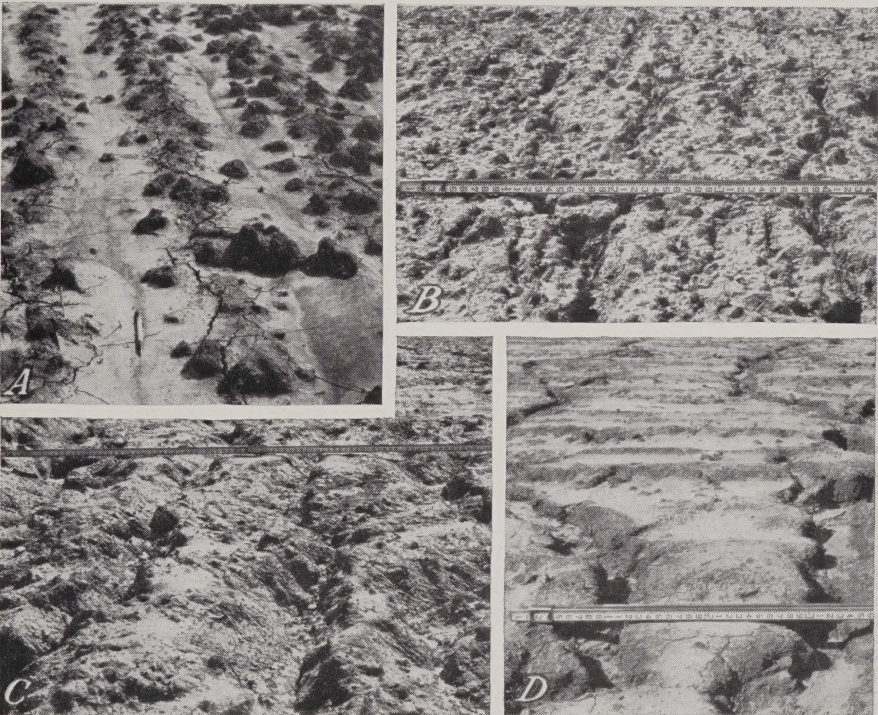
Four of the six erosion groups: *A* and *C*, respectively, represent the groups that have the least and greatest soil loss; *B* represents group 4, which has an average loss of $\frac{3}{4}$ of an inch; and *D* represents land that lost an average of $1\frac{1}{2}$ inches.

Since the amount of erosion caused by the storm varied greatly, erosion groups were used to designate the various degrees of damage. Group 1 had no erosion. Group 2 lost less than $\frac{1}{4}$ inch of soil and had an average loss of $\frac{1}{8}$ inch. Group 3 lost from $\frac{1}{4}$ to $\frac{1}{2}$ inch, with an average loss of $\frac{3}{8}$ inch. Group 4 lost from $\frac{1}{2}$ to 1 inch, with an average loss of $\frac{3}{4}$ inch. Group 5 lost from 1 to 2 inches, with an average loss of $1\frac{1}{2}$ inches. All losses of 2 inches and over were included in group 6, for which a 3-inch loss was considered average. The average depth of erosion of a group was used in determining total soil loss. Eroded areas in groups 2, 4, 5, and 6 are shown on the opposite page.

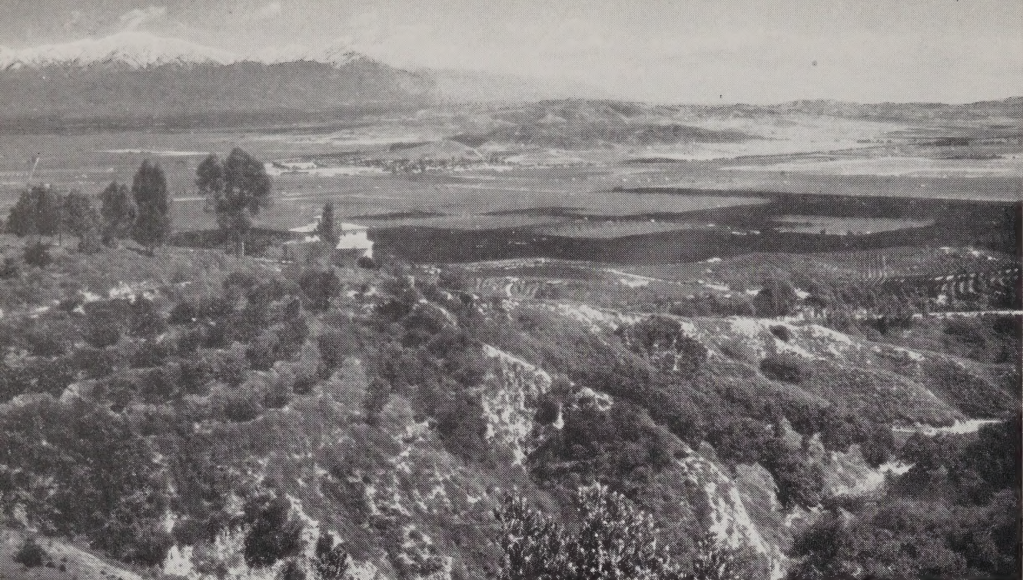
In the La Habra demonstration area (above) the steep slopes are largely protected by an excellent plant cover, and they lost little soil. The contour-planted orchard in the foreground is an avocado grove. In the background are pasture and grain lands.

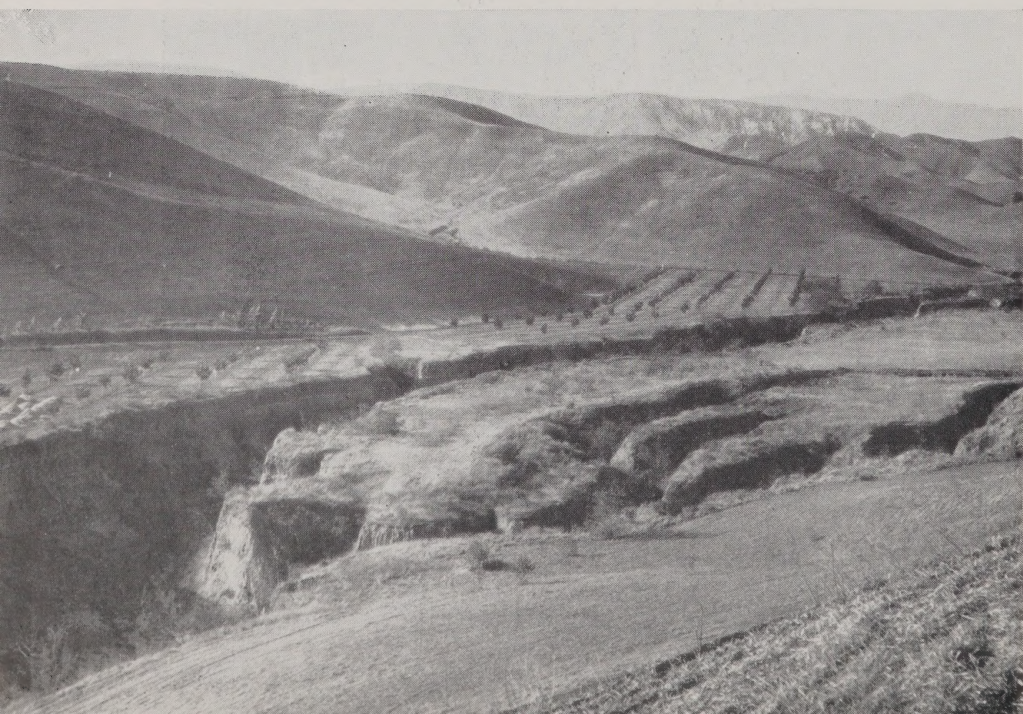
The high erosional losses in the Las Posas project (below) originated largely on areas supporting a rather poor plant cover. All the native cover on the hills in the background was destroyed by fire the fall before this picture was taken.

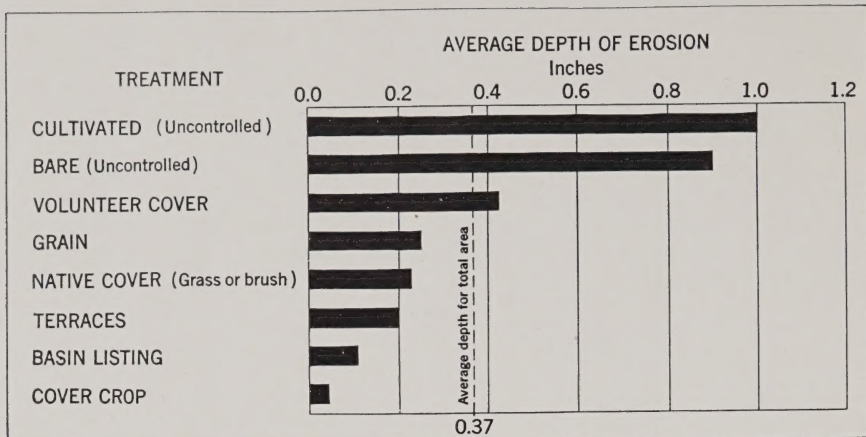
Average depth of erosion under different types of treatment on the five areas surveyed, March 1938. (See footnote 3, table 2.)

The effectiveness of measures of erosion control during abnormally severe storms is indicated by data on soil losses during this storm on both uncontrolled land and land where various types of treatment for the control of erosion are practiced (table 1). The soil losses under particular types of treatment, including both cover and mechanical controls, are recorded in table 2, and in the charts on page 8.

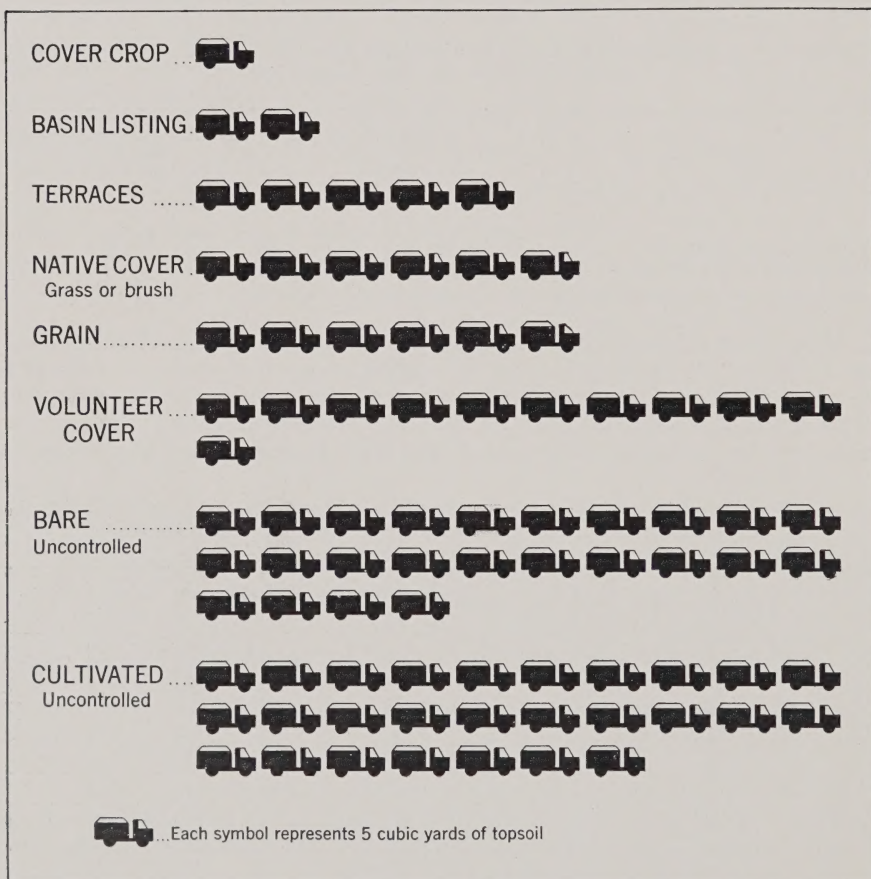
Soil loss in cubic yards per acre for land under various types of treatment on the five areas surveyed, March 1938.

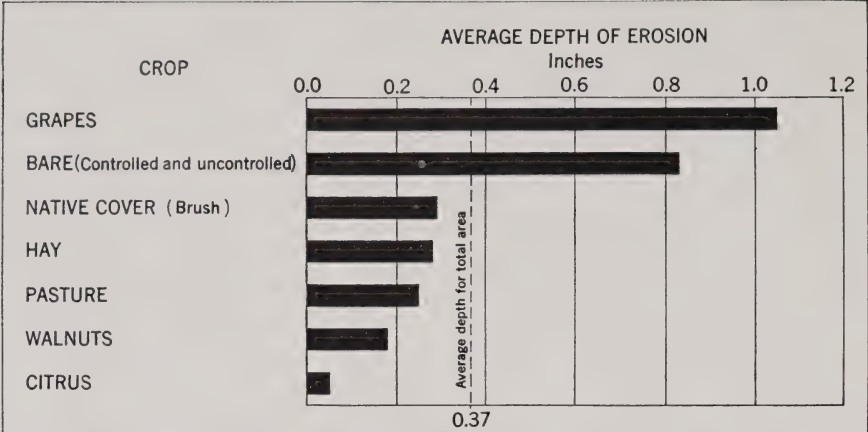
Average depth of erosion under different crops on the five areas surveyed, March 1938.

Walnut orchards had five times as much soil loss as citrus orchards, but not all of them were protected by cover crops. The average soil loss for land in grapes was particularly heavy because a 3,200-acre vineyard was severely eroded by the concentrated run-off from adjacent hills. Pastures were more resistant to erosion than hay lands. Soil losses under all crops are shown graphically on the following page.

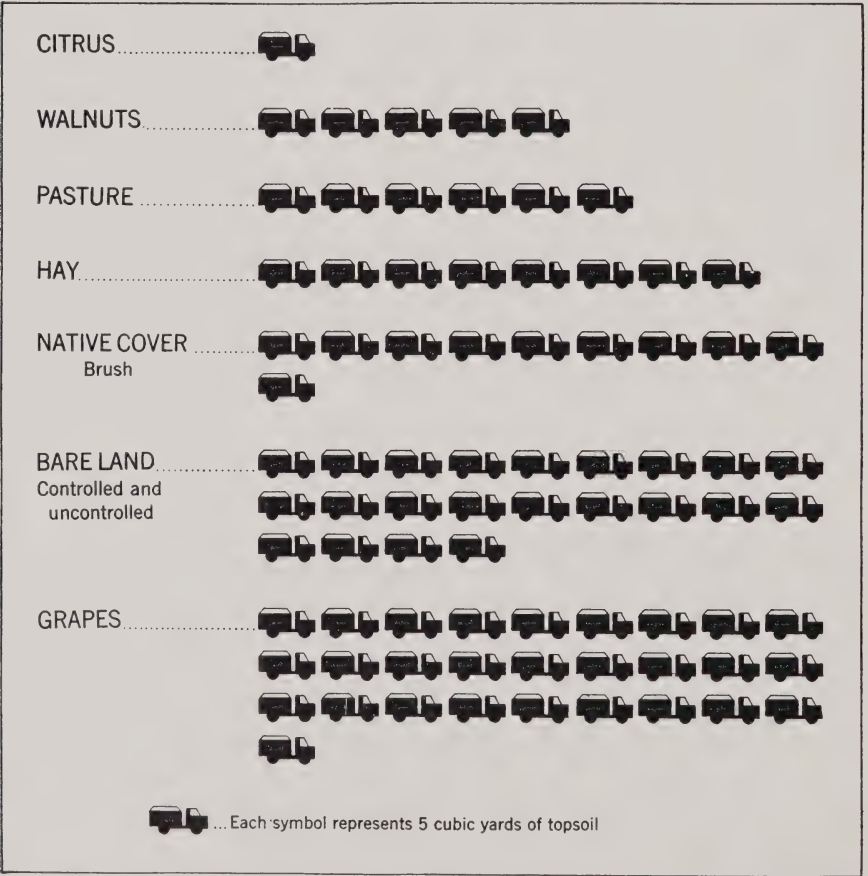
Soil loss in cubic yards per acre from land in various crops on the five areas surveyed, March 1938.

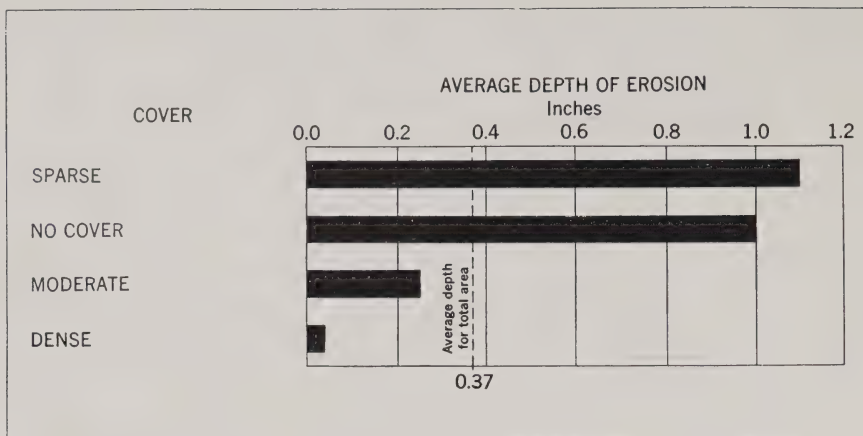
Average depth of erosion under different conditions of cover on the five areas surveyed, March 1938. (See footnote 1, table 4.)

Table 4 and the chart showing the average depth of erosion under different conditions of cover (p. 12) indicate that the density of the cover makes a striking difference in its effectiveness in resisting erosion. Of 57,090 acres of land with dense cover, on various slopes, 91 percent had no erosion and only 3 percent had a soil loss of more than one-fourth inch. Land with dense cover lost only 2.7 cubic yards per acre; and land with moderate cover lost more than 13 times as much—36.3 cubic yards per acre.

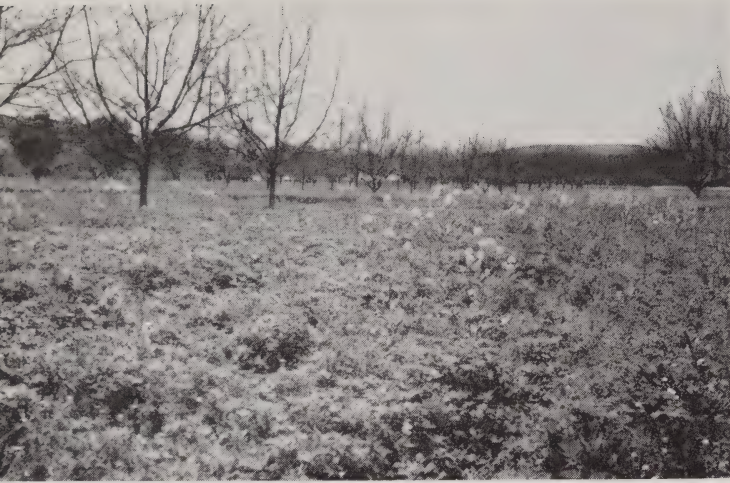
A dense early cover of *Melilotus indica* protects this 2-percent slope in Ventura County. Such areas as this were classed in this report as having no apparent erosion.

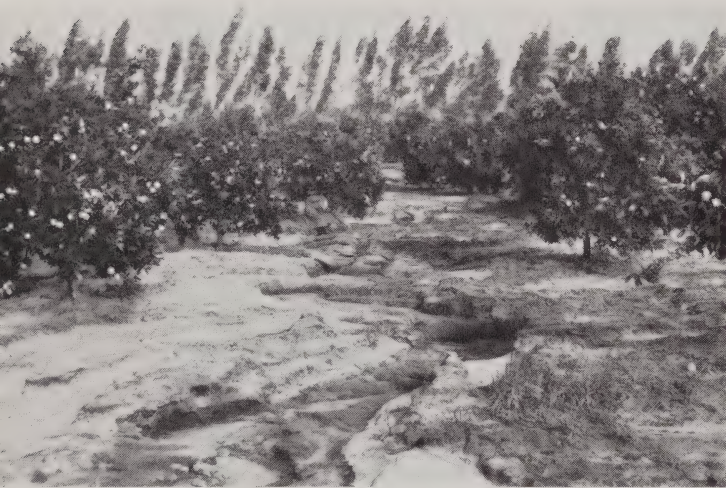
At the left is an untterraced orchard, without a cover crop. Most of the topsoil was washed from this orchard during the storm of March 2 (February 28 to March 3). Part of this heavy soil loss was caused by run-off from adjacent land.

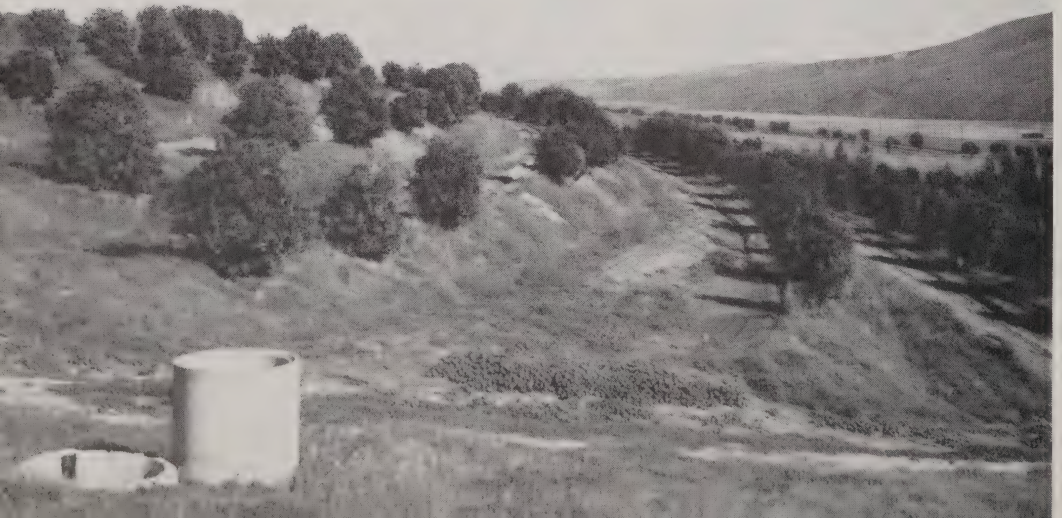
On steep slopes planted to citrus fruits, bench terraces and thick growing winter cover crops afford protection for the soil. Contour planting and other erosion-control practices have held the soil in the orchard in Ventura County that is shown below.

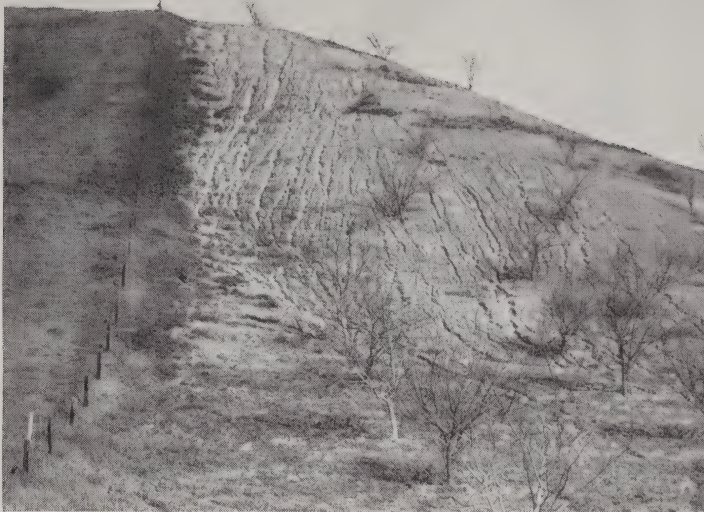
That orchards without a protective cover are subject to heavy losses of soil is shown in this picture of an apricot orchard in Ventura County (right). An average depth of $1\frac{1}{2}$ inches of soil was washed from the clean-cultivated orchard in a storm in 1934. The pasture across the fence lost no soil.

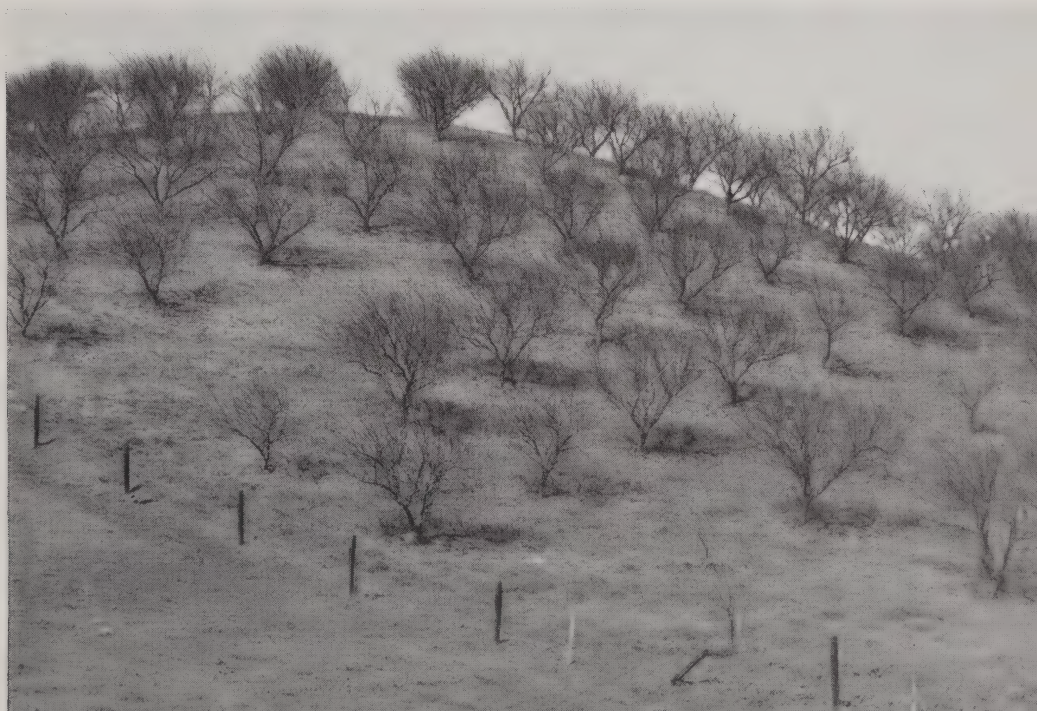
The picture below, taken about a week before the storm of March 2, shows the cover crop in an apricot grove in Ventura County. During that storm this cover held the soil.

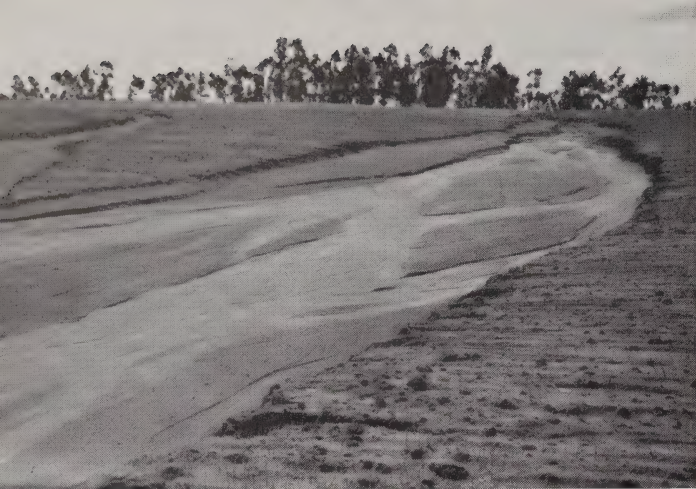
During the storm of March 2, 3 inches of soil was washed from this field (left) to pile up among the trees on a valuable orange orchard. On a slightly steeper slope of similar soil in a neighboring county (opposite page, top), basin listing and a cover crop hold the soil and water. This basin-listed field was photographed after a 4-inch rain in 2 days. During the storm of March 2 also it held the water and therefore lost no soil.

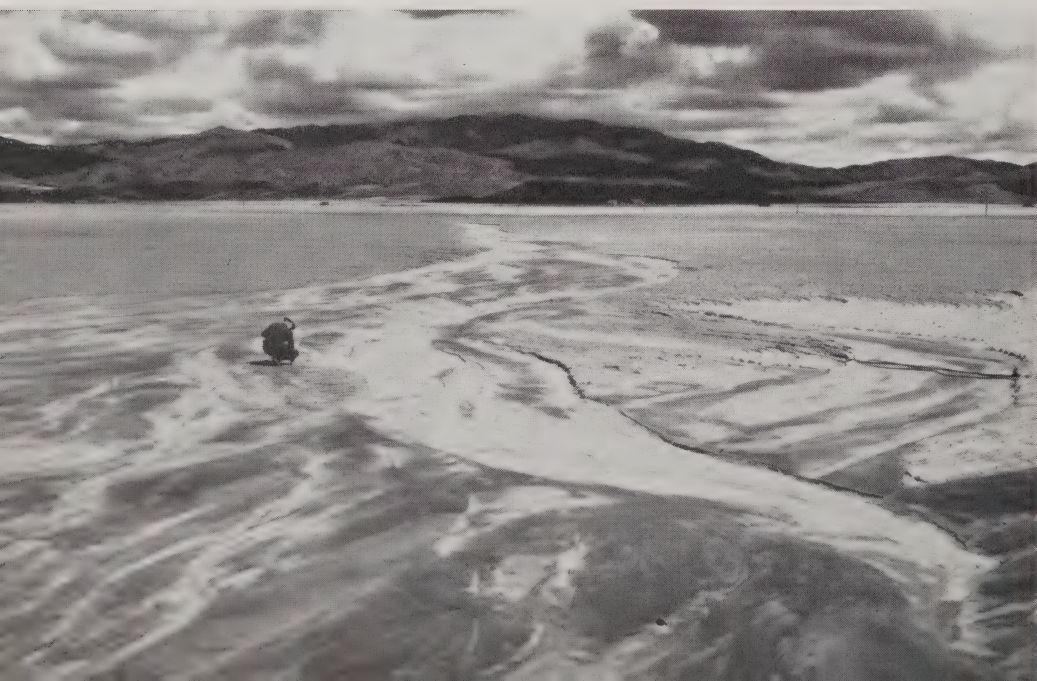
Below is shown a comparatively level, clean-cultivated beanfield that was severely eroded in this storm. Basin listing, broad-base terracing, and contour subsoiling have proved successful in controlling erosion and conserving water on similar slopes. Successfully operating terraces in Los Angeles County (center) and contour subsoiling in Orange County (bottom) are pictured on the opposite page. In the field in Orange County, hillside ditches were installed and the land was contour-subsoiled before the storm. During this storm the contour subsoiling alone retained practically all the water on the field. The ditches served to intercept what little water ran off and to prevent dangerous concentrations. Similar fields had been ditched but not subsoiled. Most of them were severely washed, and many breaks occurred in the ditches.

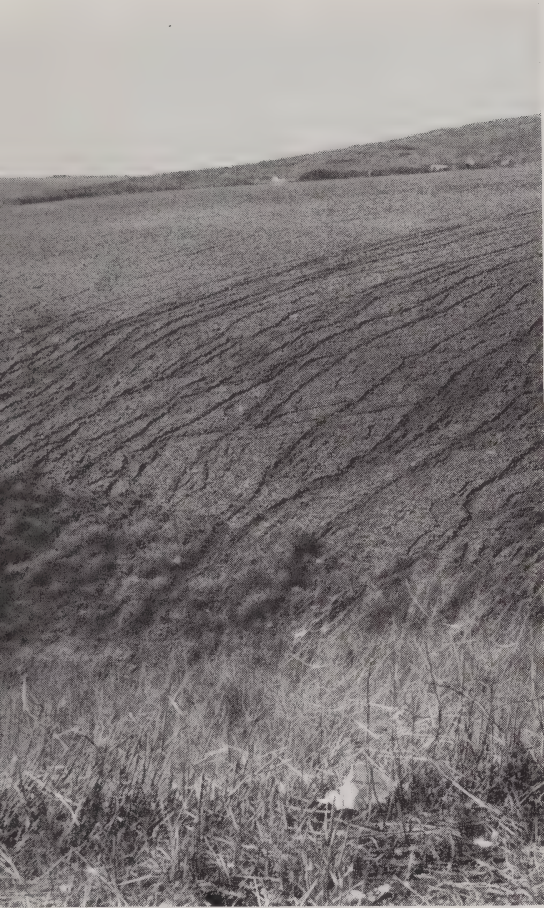
It is treatment of a slope rather than the steepness of slope that largely determines the severity of erosion. In the field to the left, rills have cut the untraced slope to the point where the natural cover begins.

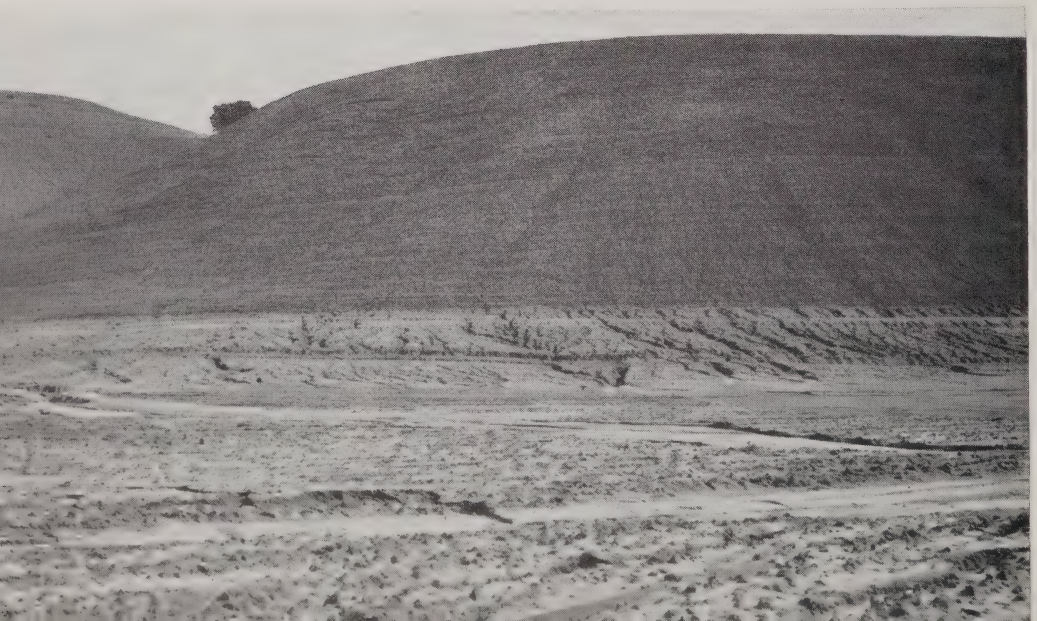
In the beanfield shown below, severe erosion begins at the foot of the steep hill, on land planted exclusively to beans year after year. During 1935 and 1936 the hill in the background was retired to a cover crop, which was plowed under in the spring of 1937. The entire field was planted to beans in 1937 and was clean-cultivated during the winter of 1937-38. The upper part of the field was cultivated once; the middle part, twice; and the lowest part, four times. The effect of the organic matter left in the soil by turning under the cover crop on the hillside is clearly shown in the greater number and size of the rills on that part of the field kept continuously in beans.

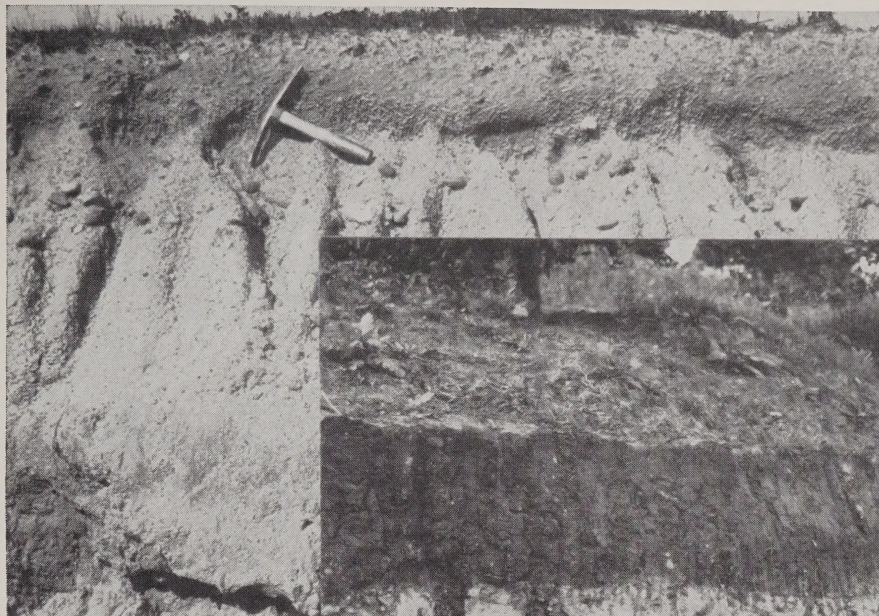
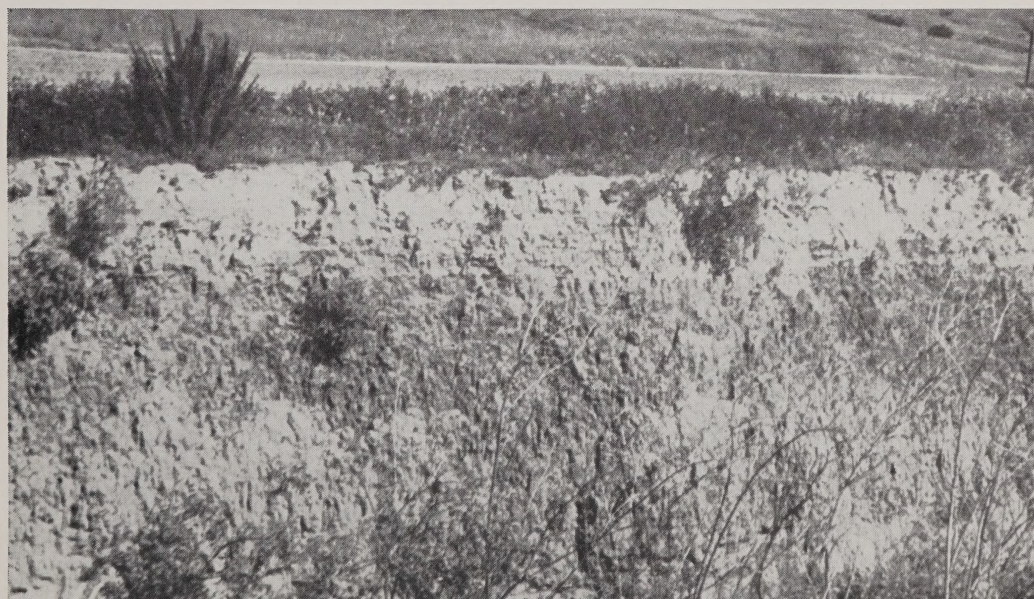
Old transported soil (left)—fine clayey particles have had time to collect at shallow depths to form a dense and relatively impervious subsoil. Primary soils (right) overlie the parent rock from which they originate. Usually these soils are very shallow, and they generally lie on steep slopes. Recently transported soils (below) show the same characteristics throughout their entire profile, often to a great depth.

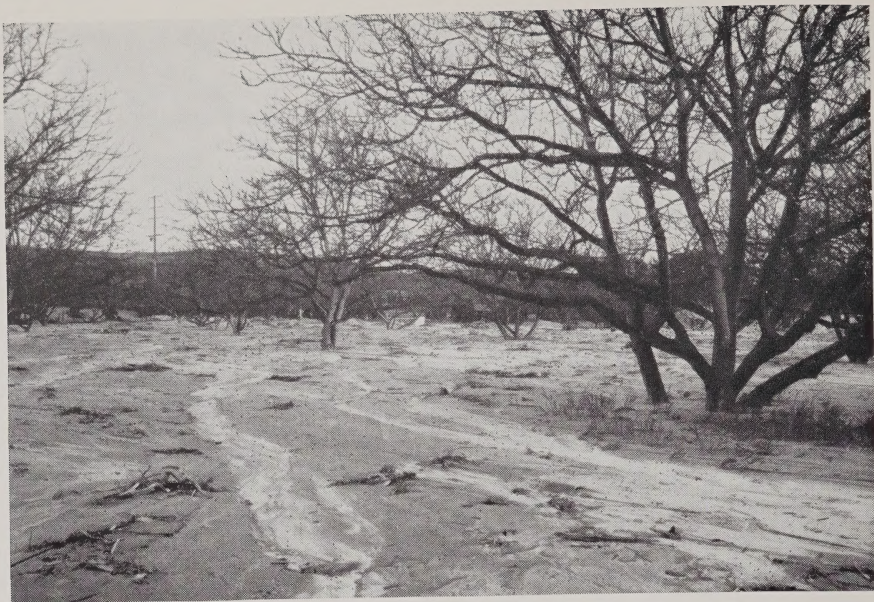
Deposition from clean-cultivated bean land 2 miles away covered this Persian (English) walnut orchard to an average depth of 3 feet during the storm of March 2.

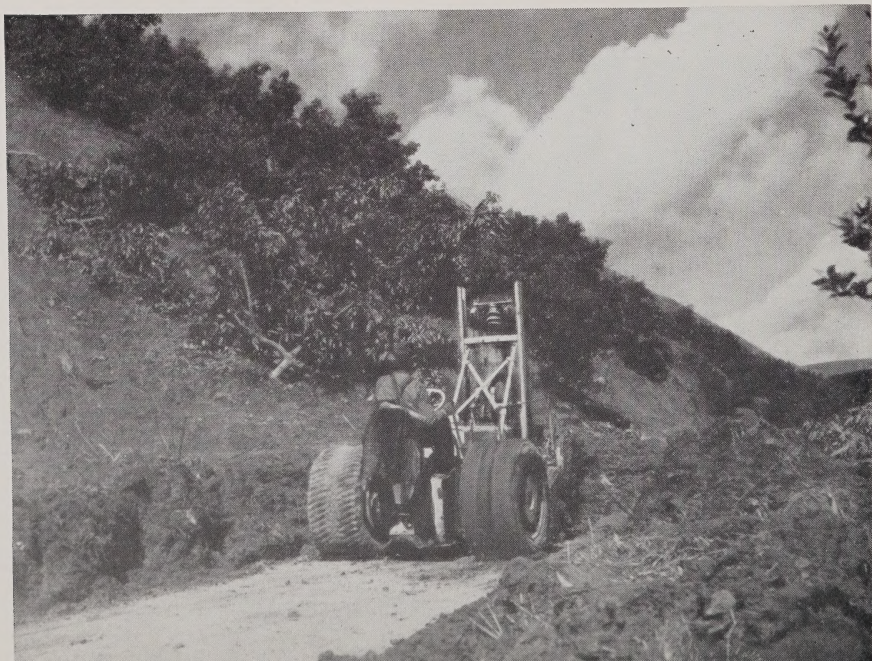
During this same storm, these bench terraces became saturated and slipped. On less than 10 acres of hillside land, 70 full-grown avocado trees were destroyed by landslips. County road-maintenance crews had to clear the roads.

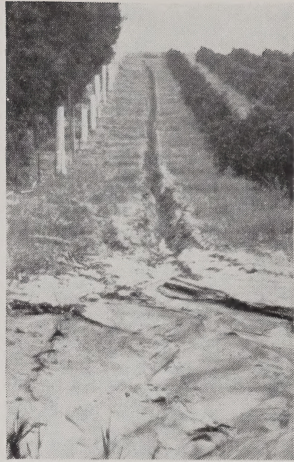
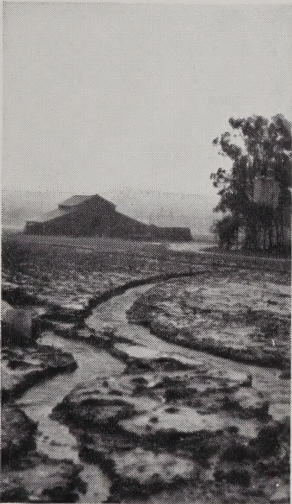
In this orchard a gully has begun to work its way up the slope in the furrow made by a root-cutting machine that was operated up and down the slope to cut off long roots extending into the grove from the windbreak on the left.

During a heavy rain, run-off from relatively flat fields (left) is enough to start erosion that may develop into gullies if it is left unchecked.

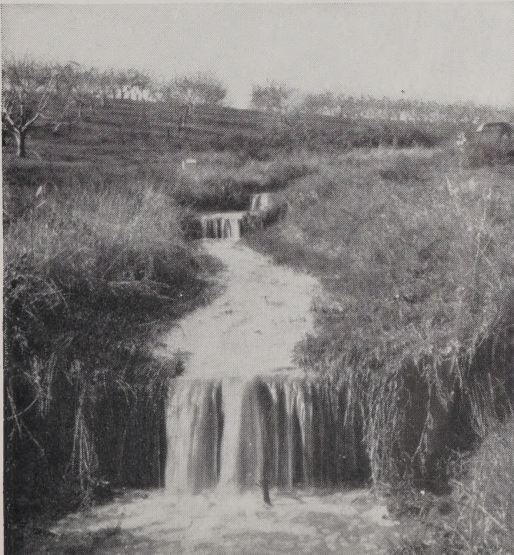
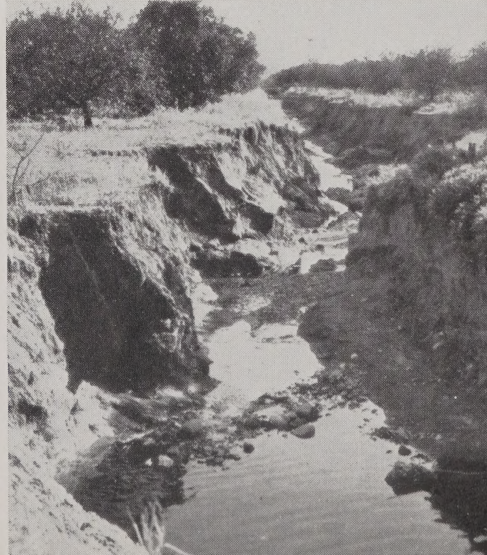
Below: Neglect of drainageways is one means of giving gullies a start. By building a few inexpensive dams and using grass to supplement this control, one farmer made a drainageway that carried run-off without gullyng (left). Another, who neglected to provide a controlled drainageway (right), saw the run-off from 10 inches of rain in 2 weeks deepen this gully as much as 10 feet in some places. Each year it will continue to increase in depth and width unless expensive control measures are installed.
